FINAL REPORT

Experimental Study on Pre-stressed Concrete Box Beams From a Decommissioned Bridge Strengthened with Carbon Fiber Reinforced Polymer Anchors and Laminates

Seyedsina Yousefianmoghadam, Ph.D. and Andreas Stavridis, Ph.D.

November 2023

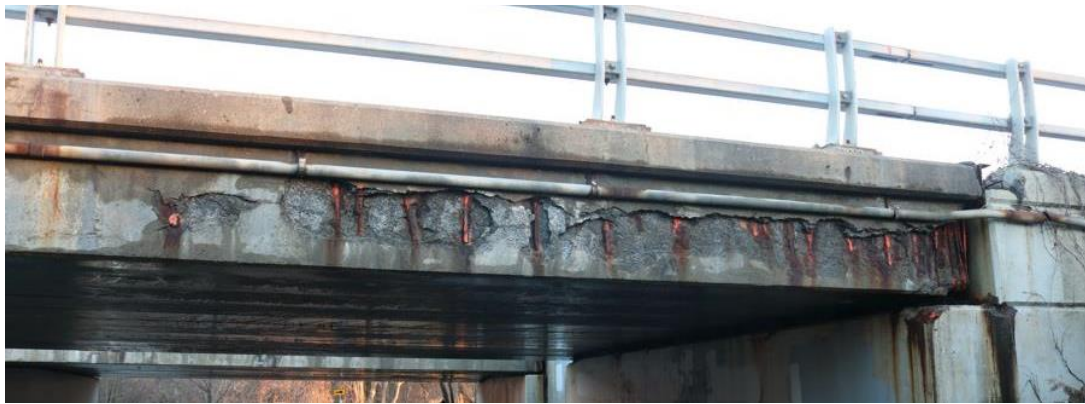
Since their construction, the bridges were subjected to severe winter conditions and consequently. Hence, they deteriorated mainly due to freeze and thaw cycles and the significant use of deicing chemicals. The deteriorated condition was documented during regular site inspections conducted by NYSDOT. The results indicated extensive surface concrete spalling with exposed stirrup bars in fascia girders. The spalling covered more than 30% of the vertical face of the exterior beams. Also, concrete spalling was observed at the end block of the prestressed beams, exposing the stirrups and prestressing tendons. Figure 2-3 presents examples of observed deterioration. A Yellow Flag was issued by NYSDOT prior to 2016 for some of the abovementioned deficiencies which were not repaired.

a) Spalled concrete and corroded reinforcement at a fascia beam

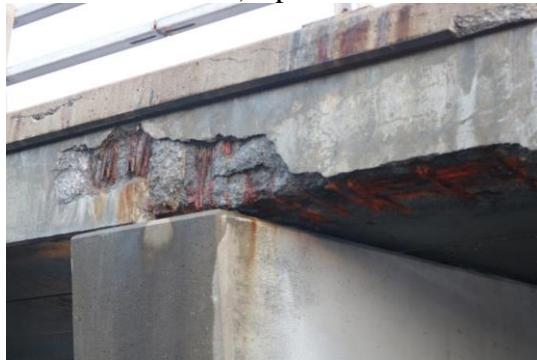
b) damage at the pier support

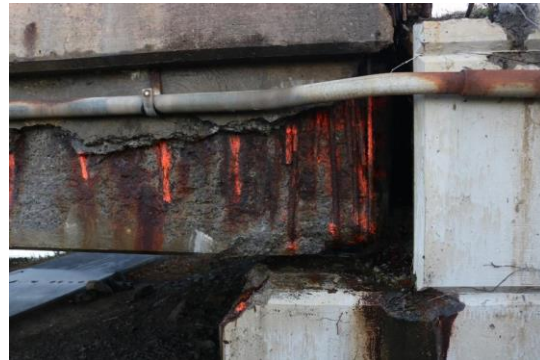
c) damage at the abutment

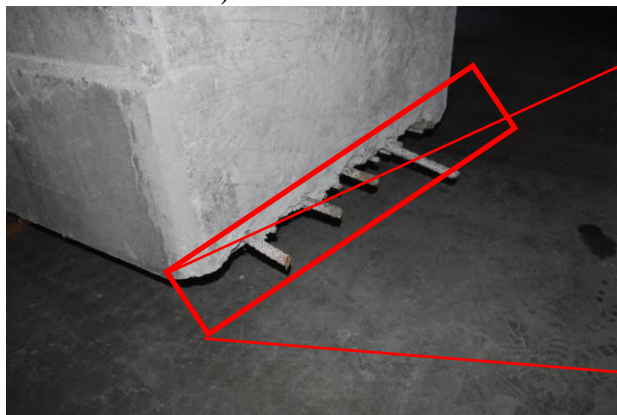
the west end, shown in Figure 2-6d, no other sign of damage or deterioration was observed. It should be noted that the cardinal coordinates, based on the beam orientation during testing at the SEES laboratory, are used in this report to refer to the various locations along their length. For instance, the “west end” refers to the end of the beam that is closer to the west side of the laboratory which remains the same for the entire testing period.

d) Steel reinforcement and concrete condition at the west end of the beam

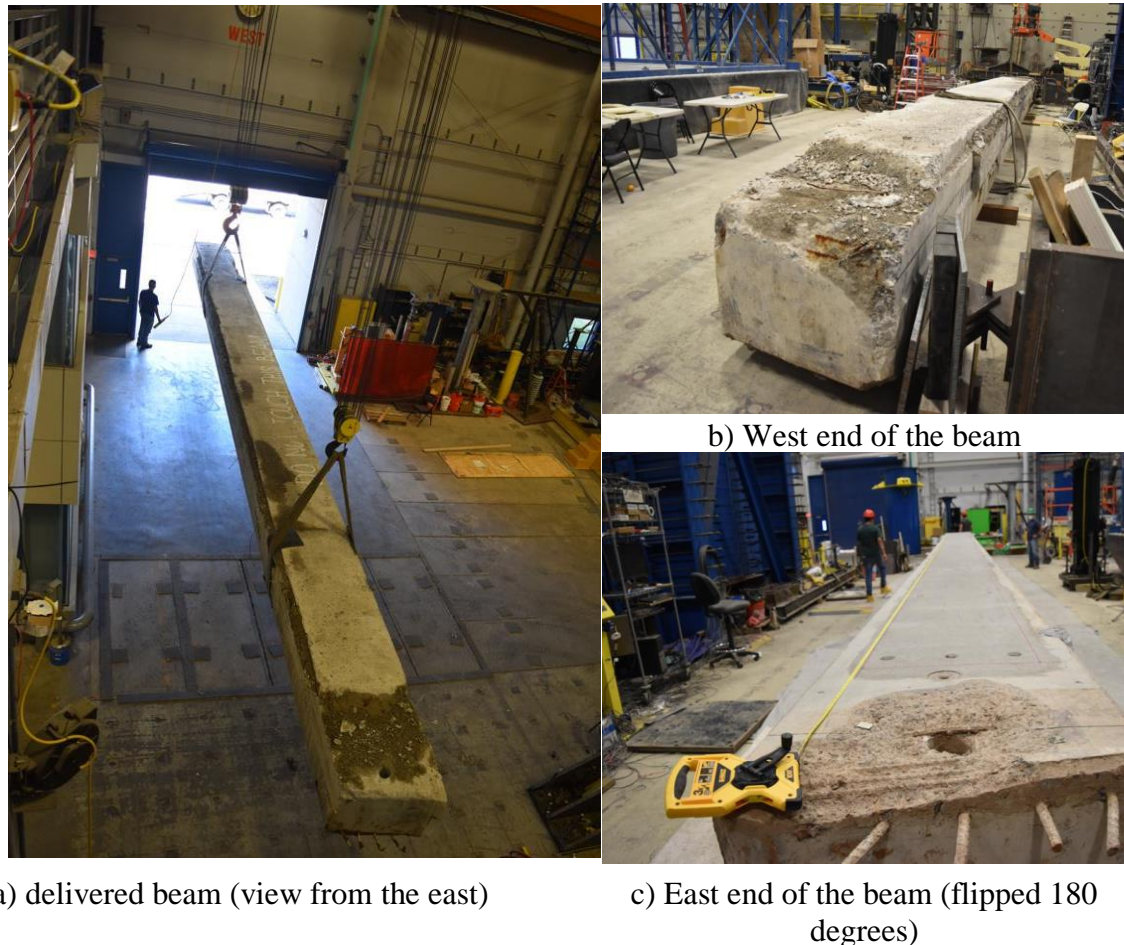
Figure 2-7 Overall condition of Beam 2 after delivery to the SEES laboratory

SEESL. Corrosion of transverse steel and concrete spalling were observed on both ends as shown in Figure 2-7b, and c. No visible shear or flexural crack was observed.

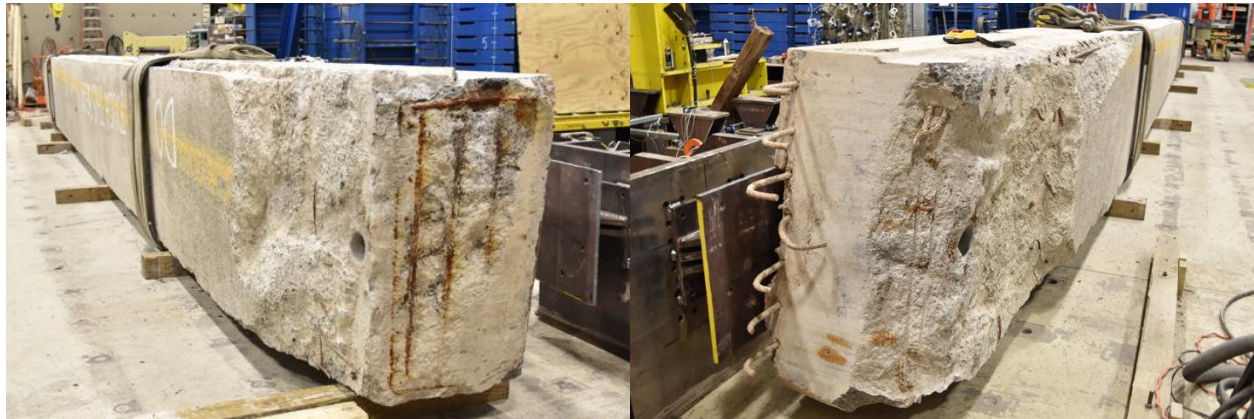
The overall condition of Beam 3 is shown in Figure 2-8. Similar to the other two beams, the deck slab was removed at both ends of Beam 3. However, more severe damage was observed in Beam 3 at its ends, when compared to Beams 1 and 2, in terms of concrete spalling and corrosion of the transverse steel as shown in Figure 2-8a and b. Also, concrete spalling at the beam substrate occurred at several locations along the length of the beam due to the forceful beam removal using the excavators. Examples of the demolition-induced damage are presented in Figure 2-8c and d. This damage did not affect the load carrying capacity of the beam; however, it would reduce the bonding area and the effectiveness of the FRP retrofit. Hence, as discussed in Chapter

a) West end of the beam (flipped 90 degrees)

b) East end of the beam (flipped 90 degrees)

3, the beam was patched prior to the application of the FRP layer. As with Beams 1 and 2, no visible shear or flexural cracks were observed prior to the FRP application.

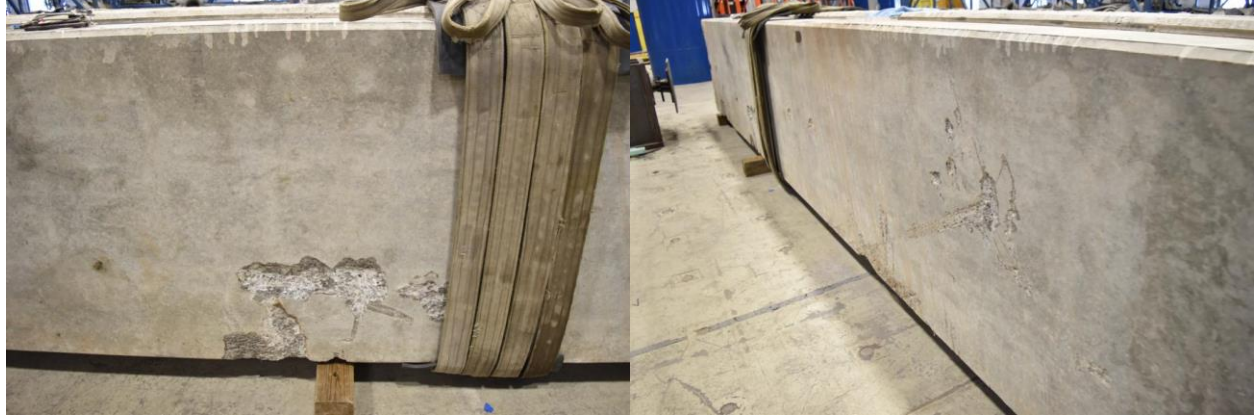
c) Damaged beam substrate

d) Damaged beam substrate

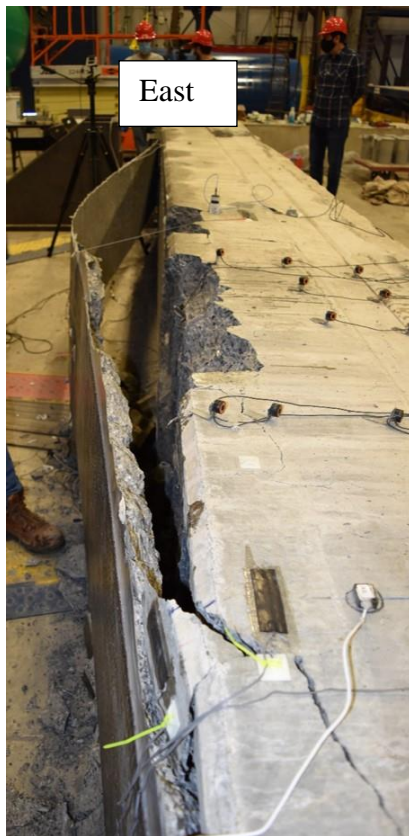
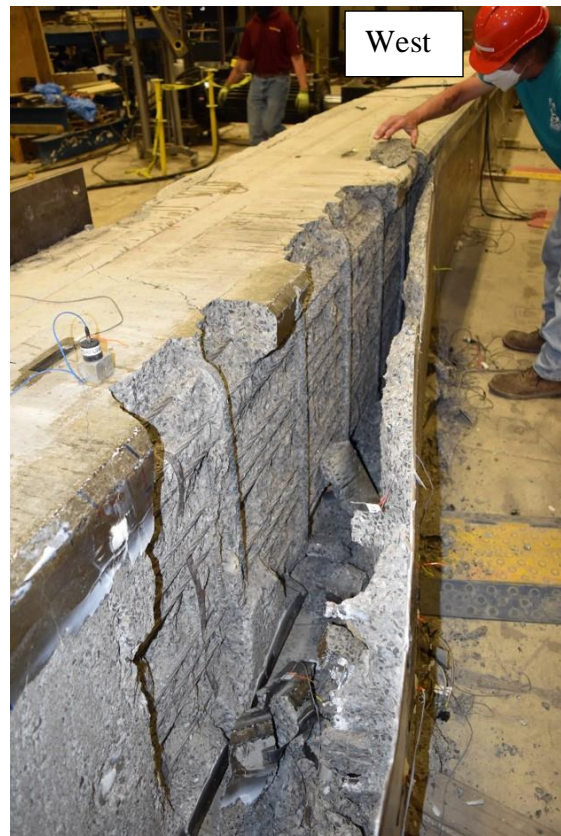
the beam, rupturing one anchor and leaving the other two in place as shown in Figure 5-17. The retrofit on the east side of the beam did not exhibit noticeable damage. It should be noted again that this difference in the state of damage between the east and west sides was most likely the result of the difference in the applied forces between the actuators that resulted in unsymmetric loading. Since the FRP system could not provide any resistance beyond its failure, the loading of the beam was continued, as this would allow to obtain the behavior of the unretrofitted beam. The loading stopped once the beam failed due to concrete crushing on the compression side.

Figure 5-15 Concrete spalling and FRP delamination at the west actuator location

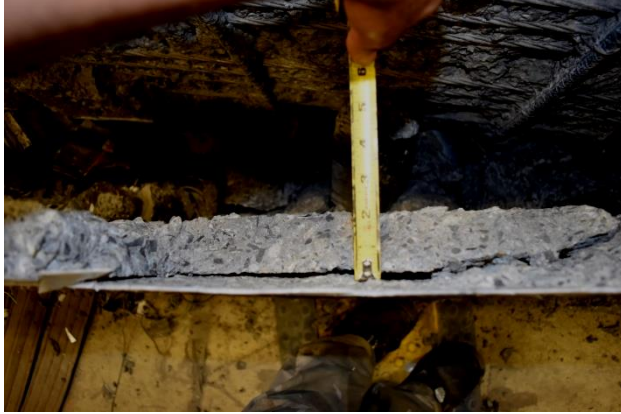
a) spalled concrete cover

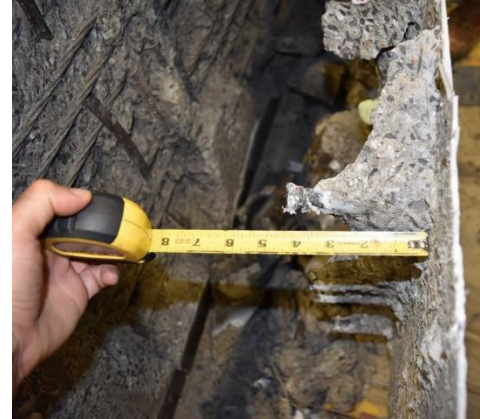
b) anchors pulled out

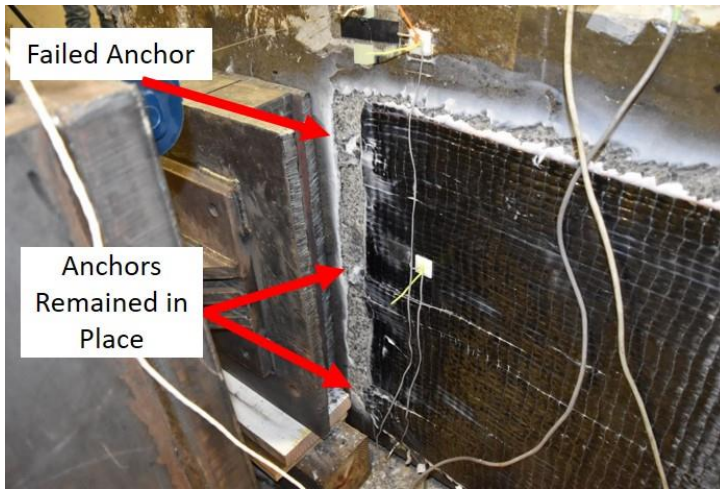
a) slid FRP laminate

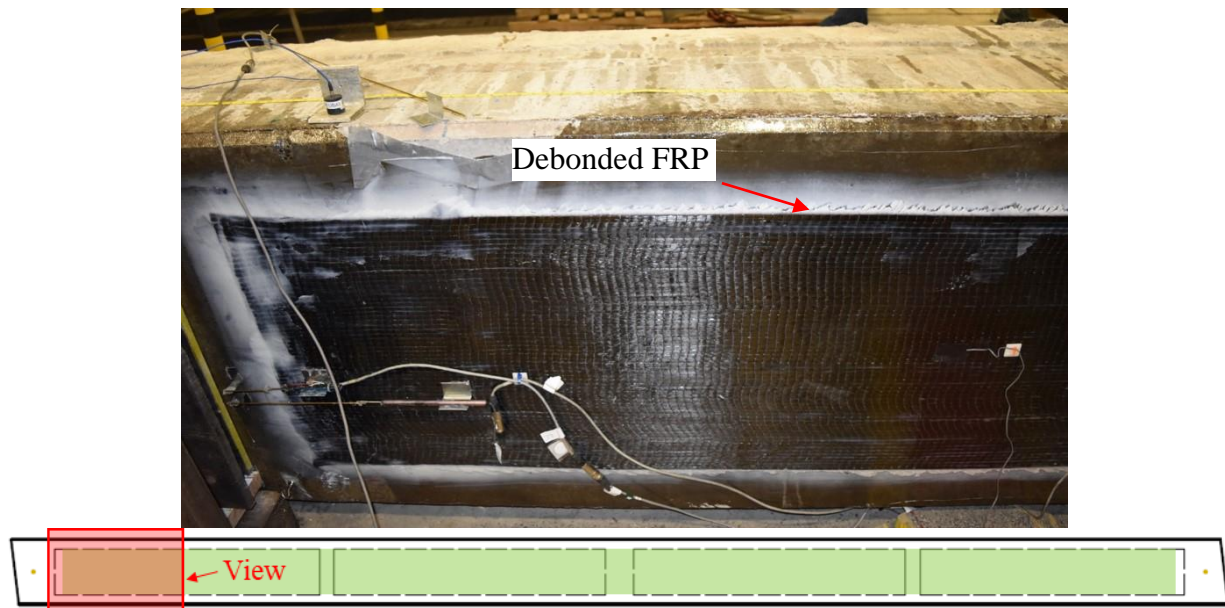
Figure 5-30 FRP Debonding at the West end

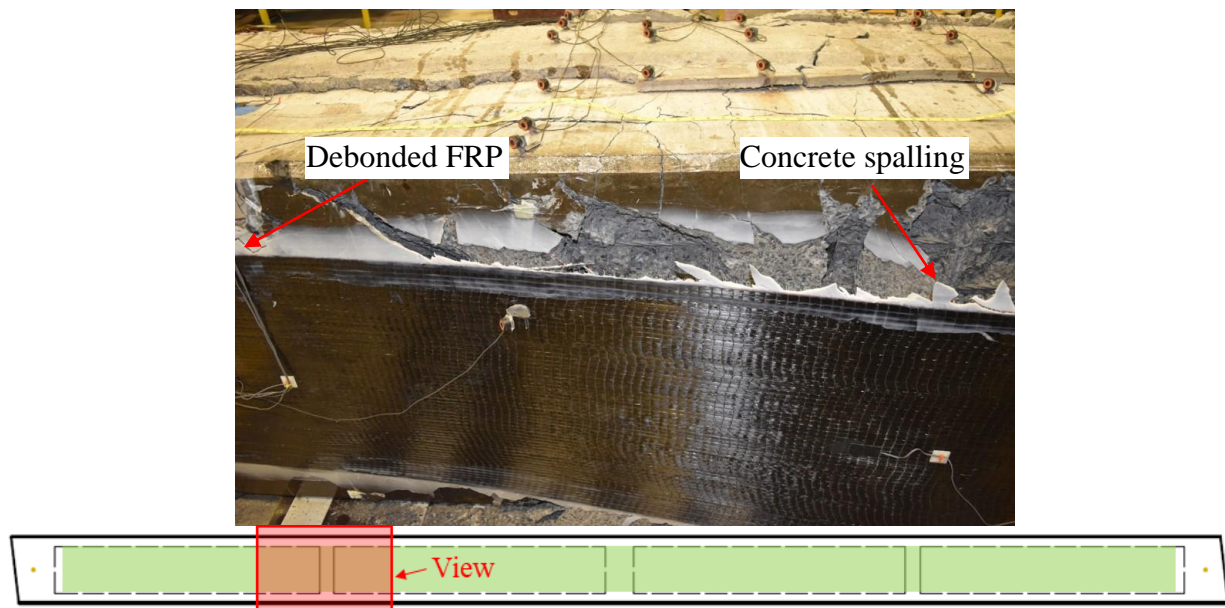
Figure 5-31 Transitioning from FRP debonding to concrete spalling at the West actuator location

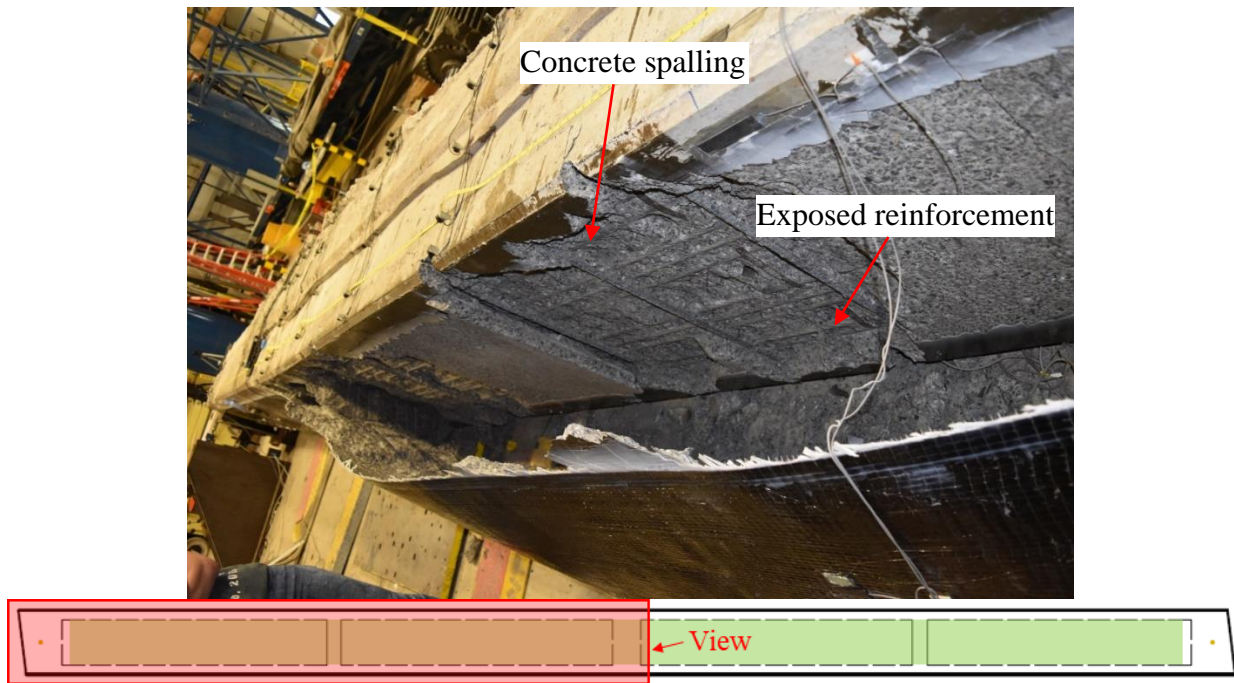
Figure 5-32 Concrete spalling at the maximum moment zone

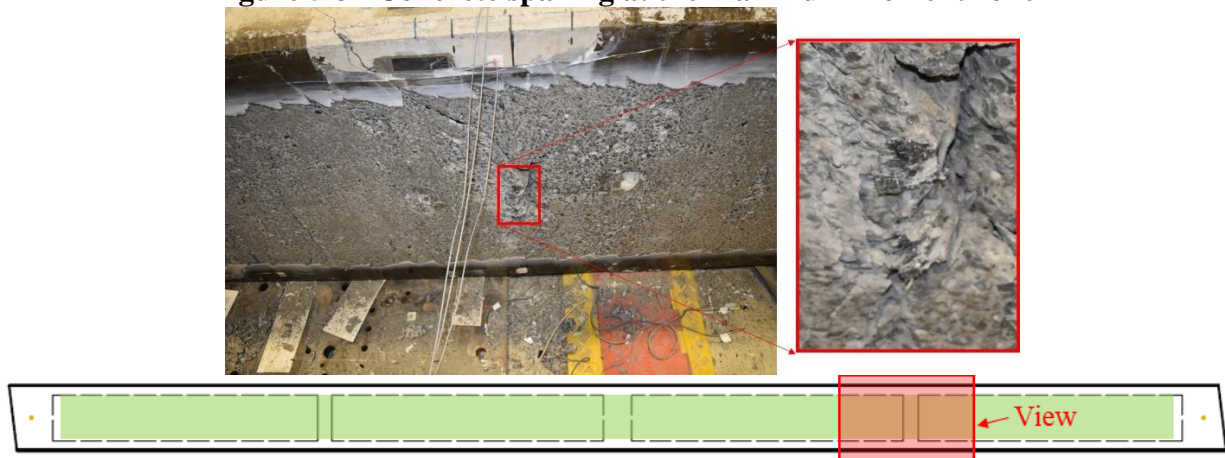
Figure 5-33 Anchor breakage at the east solid segment

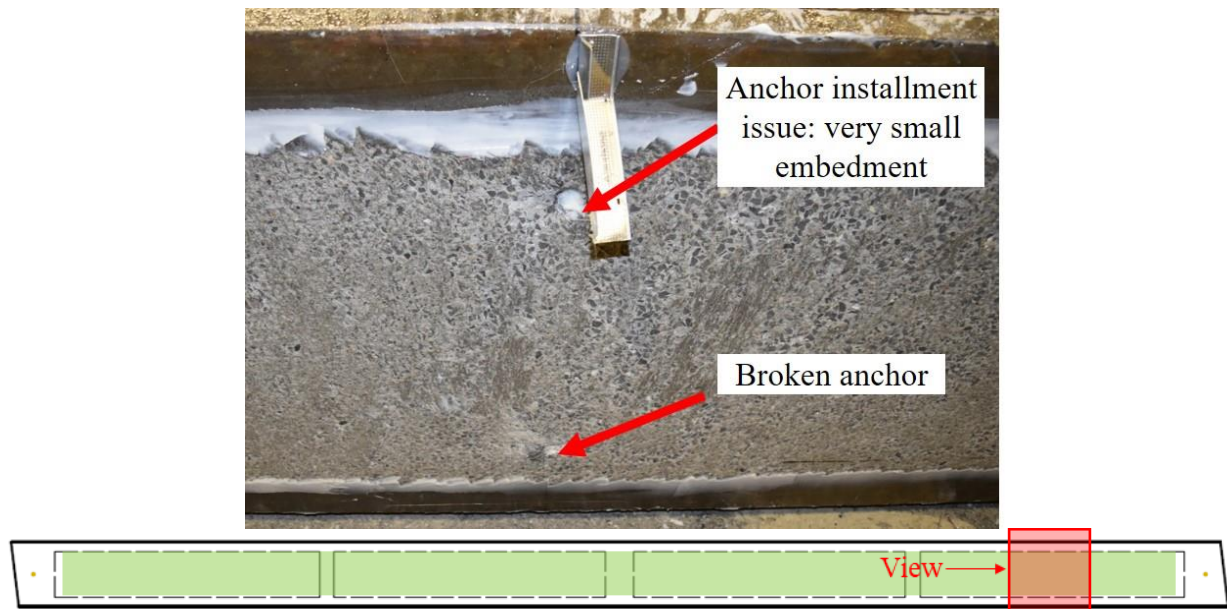
Figure 5-34 Status of Anchors at the east hollow segment

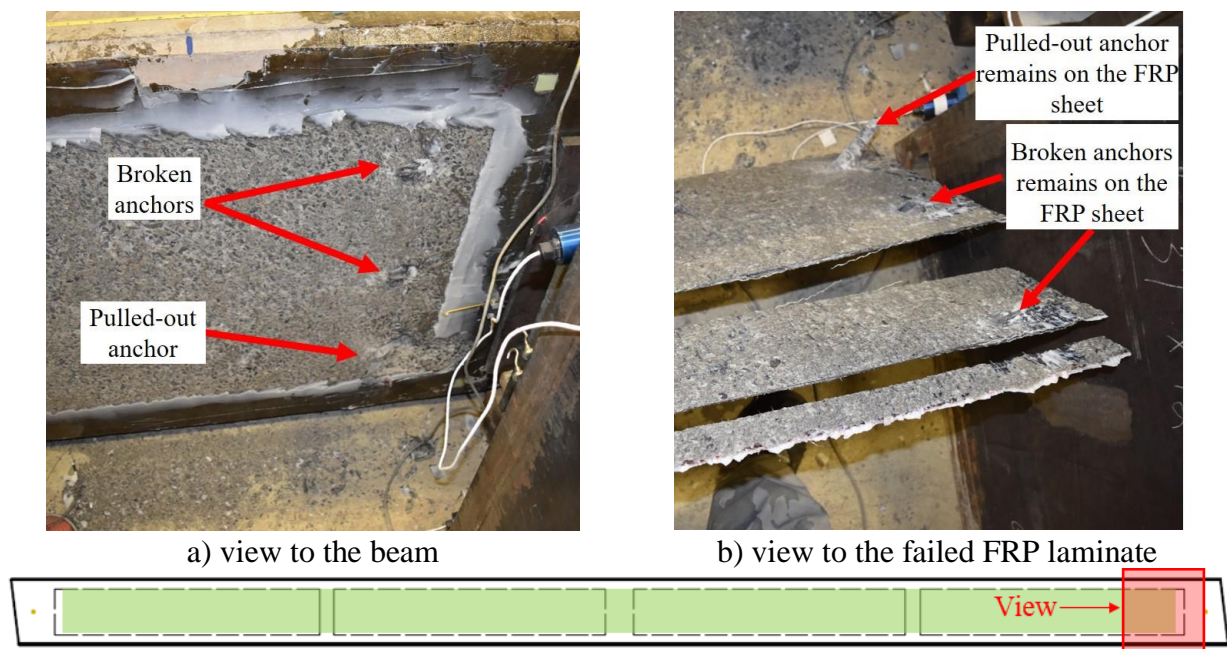
Figure 5-35 Status of Anchors at the east end

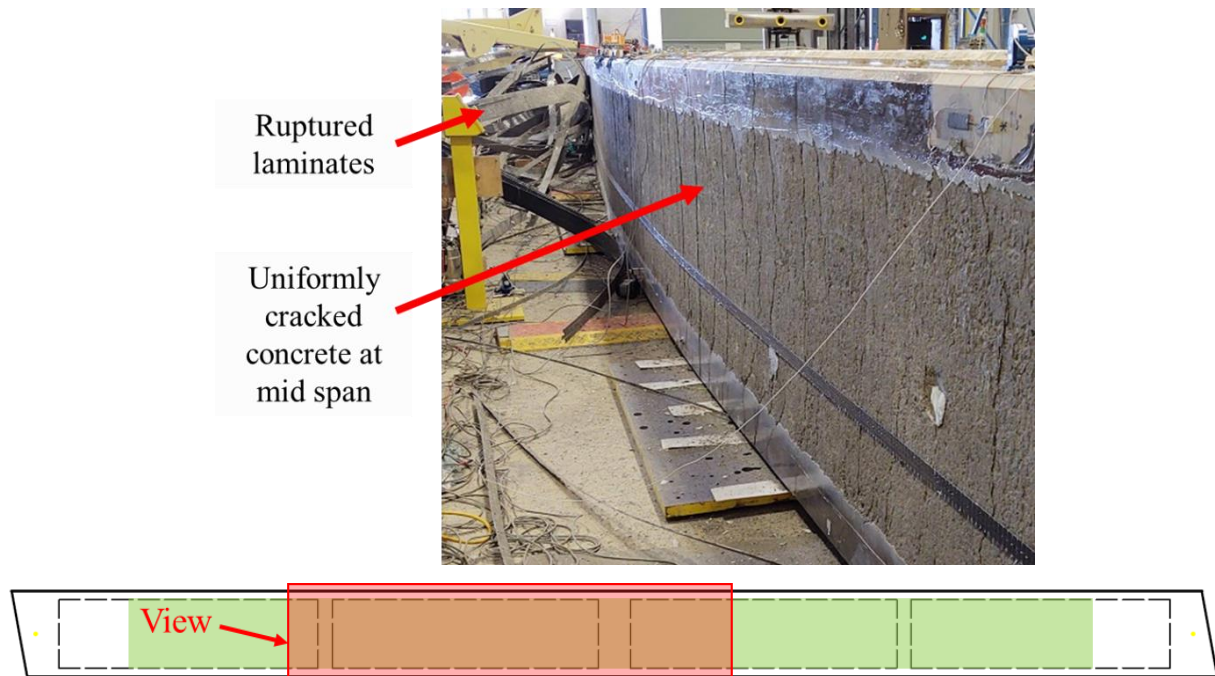
Figure 5-46 State of damage at the middle of Beam 3

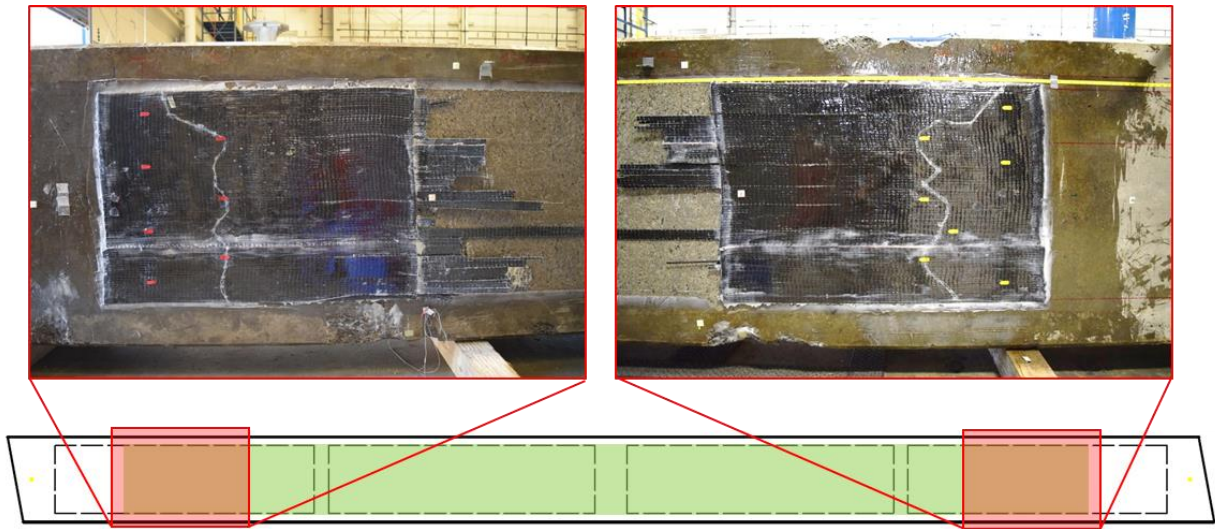
Figure 5-48 State of damage at the end zones of FRP laminate
