FINAL REPORT

Experimental Study on Pre-stressed Concrete Box Beams From a Decommissioned Bridge Strengthened with Carbon Fiber Reinforced Polymer Anchors and Laminates

Seyedsina Yousefianmoghadam, Ph.D. and Andreas Stavridis, Ph.D.

November 2023

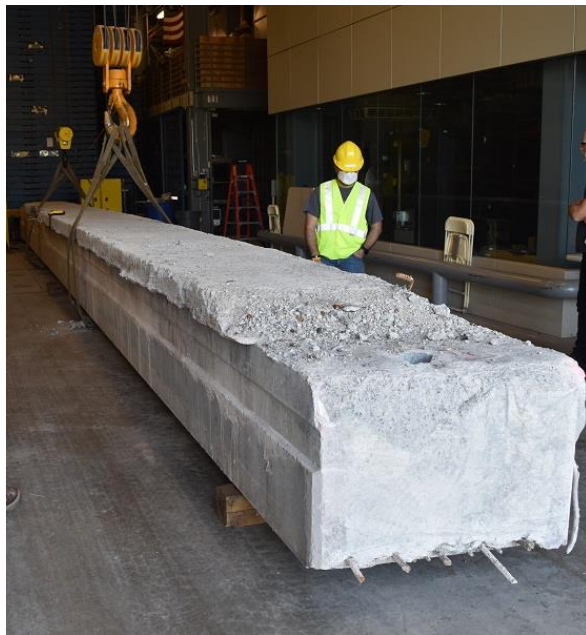
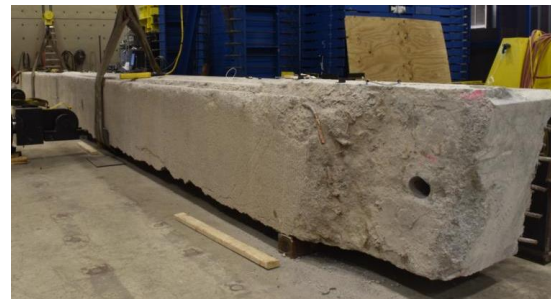
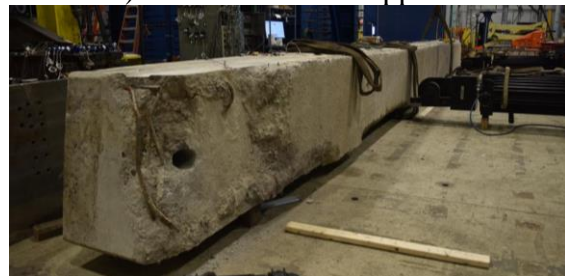
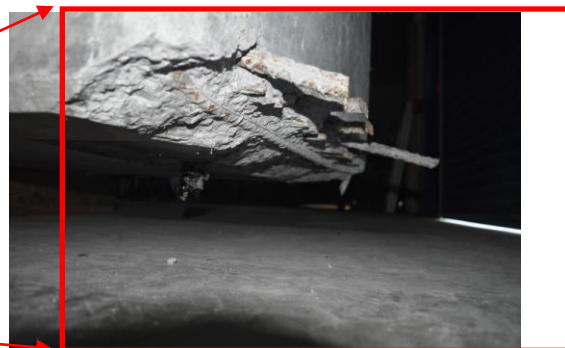
Figure 2-6 Overall condition of Beam 1 upon delivery to the SEES laboratory

Beam 1 is shown in Figure 2-6. As discussed before, the concrete deck slab on both ends of the beam was removed prior to delivery. Except for minor concrete spalling and steel corrosion at

the west end, shown in Figure 2-6d, no other sign of damage or deterioration was observed. It should be noted that the cardinal coordinates, based on the beam orientation during testing at the SEES laboratory, are used in this report to refer to the various locations along their length. For instance, the “west end” refers to the end of the beam that is closer to the west side of the laboratory which remains the same for the entire testing period.

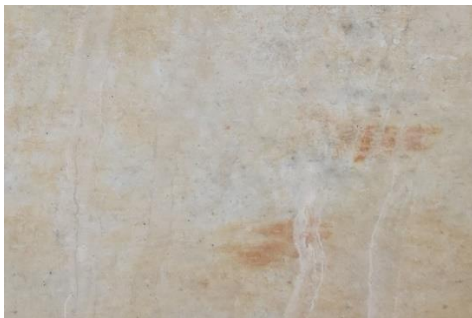
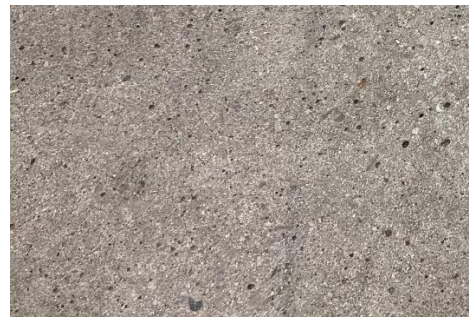
Figure 3-4 Change in the surface profile due to grinding

The concrete surface where the FRP laminates and anchors are installed must be clean, dry, and free of cavities that may cause voids behind the laminates. A diamond wheel grinder was used to clean the concrete surface as well as to increase roughness and enhance the bond between the CFRP laminates and the concrete. The roughness of the grinded surface, shown in Figure 3-4, was close to the Concrete Surface Profile 3 (CSP 3), as defined by the International Concrete Repair Institute (ICRI) Technical Guideline No 310.2 (ICRI, 2013). It should be noted that the surface cleaning and roughening can be completed in the field using other methods such as sandblasting and water blasting which are more efficient options for in-situ applications. However, these could not be applied within a laboratory setting for practical reasons. In addition to this step, the surface cavities of Beam 3, which resulted from concrete spalling during the demolition, as discussed in Chapter 2, were also patched by the same epoxy used to provide a bond between concrete and CFRP laminates. This was done a few days before the application of the CFRP laminates to allow the epoxy to harden. Patched surfaces were also roughened after hardening using sandpaper. Other methods could also be employed for patching the concrete depending on the extent of the damage.

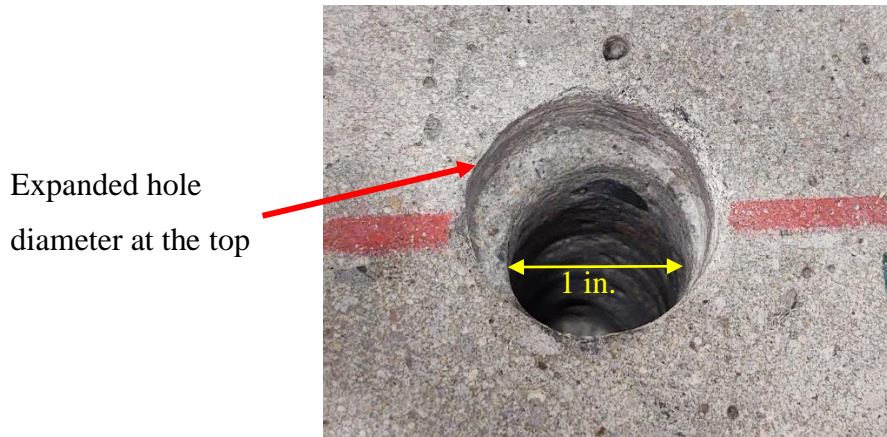
Figure 3-5 Example of the drilled holes

After the surface was prepared, 1-in.-diameter 4.5-in.-deep holes were drilled according to the design layout for each beam. The holes were $\frac{1}{4}$ in. wider and $\frac{1}{2}$ in. deeper than the anchor diameter and embedment depth, respectively. This is standard application practice as it allows for the epoxy to surround the anchor and provide a strong bond between the anchor and concrete. The top $\frac{1}{2}$ in. of each hole was also widened by $\frac{1}{4}$ of an inch in diameter towards the side of the anchor spread on the beam surface, as shown in Figure 3-5. This was done to prevent the anchor from bending 90 degrees and reduce the bearing stress concentration between concrete and the anchor at the bent segment of the anchors.

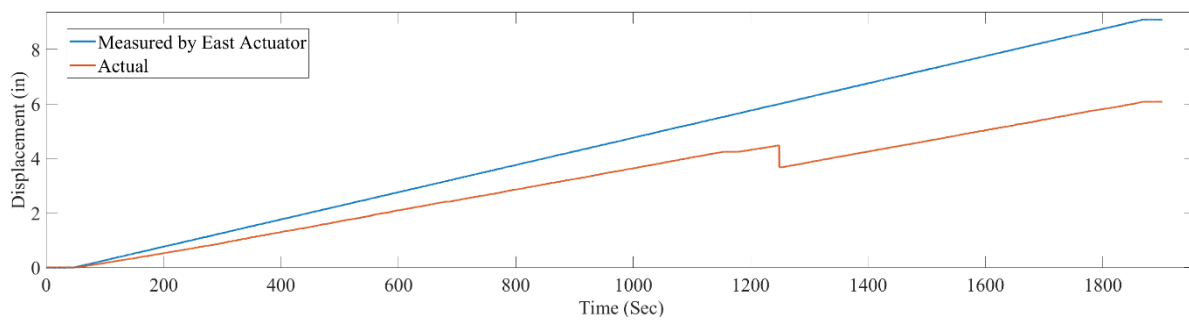
was completed, the reason for this discrepancy was investigated. The investigation after the tests concluded that the observed difference was a result of an error in the measurements of the displacement of the east actuator.

This is presented in Figure 5-11, which shows that the actuator displacement reading, which was used by a controller to give displacement commands to the actuator, was exceeding the actual displacement due to a calibration error. Therefore, the east actuator was only displacing about 80% of the given command and consequently, it was applying lower force compared to the west actuator. This problem was fixed for the following tests.

Figure 5-11 Error in the displacement read by the East actuator

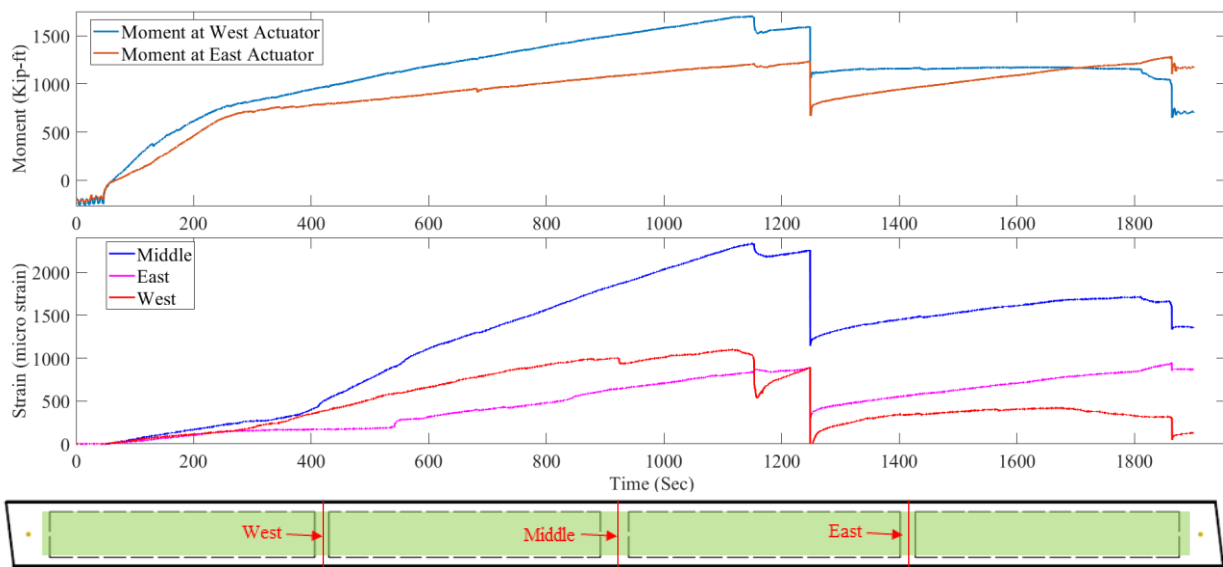
Beyond the cracking moment, the beam resisted the increasing demand until debonding was initiated on the west side of the beam as shown in Figure 5-12. The debonding caused a drop in the strain on the west of the beam as illustrated in Figure 5-14. A smaller strain drop was recorded at the middle while a slight increase in the strain occurred on the East side. This observation indicates that the force along the FRP laminate was redistributed and therefore, the moment resistance started to increase following the debonding. This increase was interrupted by FRP delamination, concentrated mainly on the West side, as indicated by the drop in the moment and strain in Figures 5-12 and 5-14, respectively, marking the failure of the FRP system.

Figure 5-14 Strain variation on the FRP laminate during the capacity test of retrofitted Beam 1

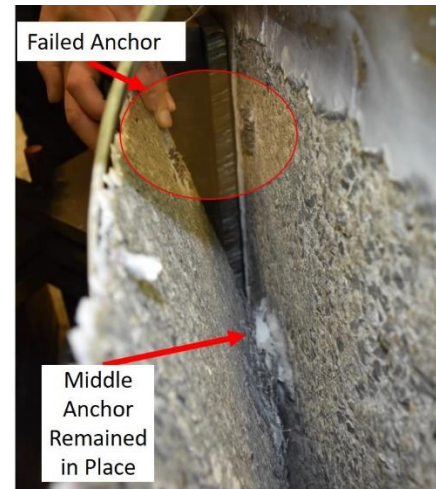
b) view to FRP-concrete interface

Figures 5-15 through 5-17 present the state of the damage following the FRP failure. Spalling of concrete cover attached to the FRP was observed, exposing the prestressing strands. Also, the anchors on the west side of the beam were pulled out along with a cone of concrete surrounding them as shown in Figure 5-16. The FRP laminate slid relative to the concrete at the west end of

the beam, rupturing one anchor and leaving the other two in place as shown in Figure 5-17. The retrofit on the east side of the beam did not exhibit noticeable damage. It should be noted again that this difference in the state of damage between the east and west sides was most likely the result of the difference in the applied forces between the actuators that resulted in unsymmetric loading. Since the FRP system could not provide any resistance beyond its failure, the loading of the beam was continued, as this would allow to obtain the behavior of the unretrofitted beam. The loading stopped once the beam failed due to concrete crushing on the compression side.

Figure 5-17 FRP sliding at the West end of Beam 1

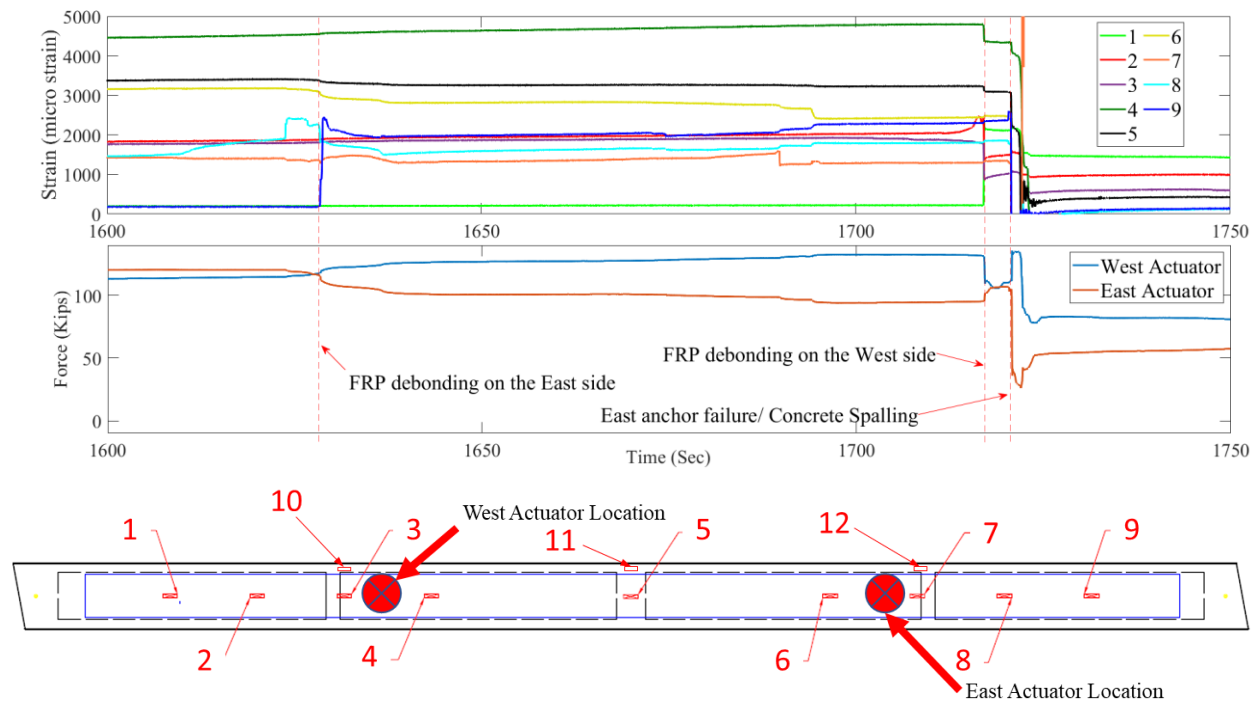
Following the beam cracking, the applied load was resisted until debonding of FRP laminate was initiated on the East side of the beam as indicated in Figure 5-26. The debonding can also be inferred from the drop in the strain on the East of the beam as illustrated in Figure 5-28 and Figure 5-29. It can be also observed from Figure 5-29 that the strain in the laminate increased at the east end, indicating a redistribution of the force. Following this event, the total force resisted by the beam remained constant until debonding of FRP laminate occurred on the west side, which was shortly followed by FRP delamination and concrete spalling as the bond between the FRP and the concrete was strong enough to cause spalling of the concrete cover. This sequence of events can be observed in the plots of Figure 5-29 that focus on the failure region of response.

Figure 5-29 Variation of strain during the failure of the FRP retrofit
